Property Report Interior Visual and Practical Plus Exterior

19 April 2021

COCKLESHELL
COTTAGE

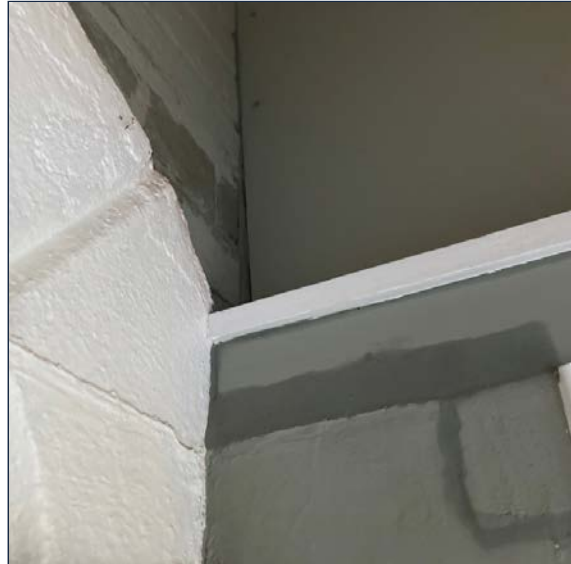
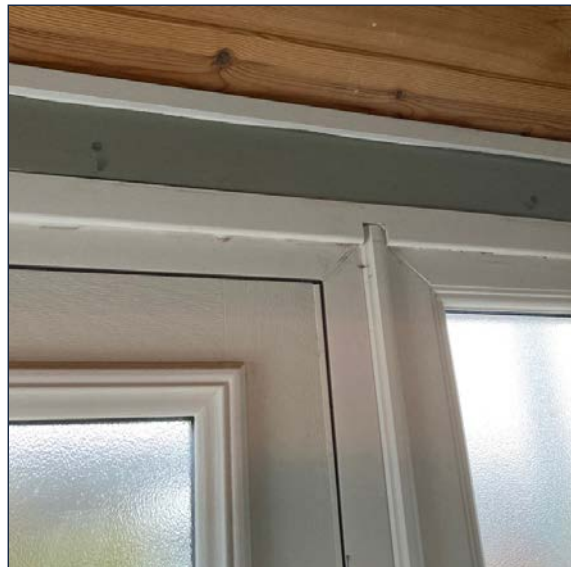
Defect Photography 1

There are signs of water ingress and the UPVC trim above the door is loose and coming away.

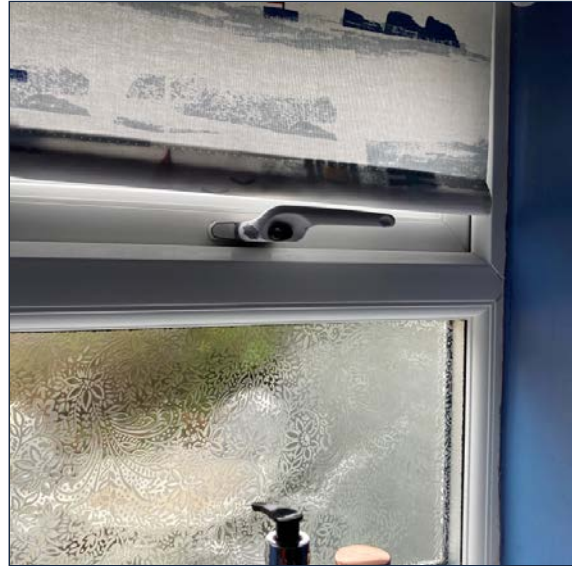
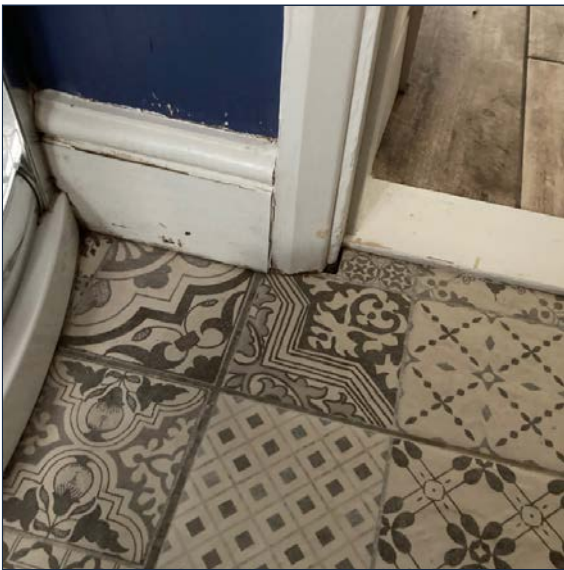
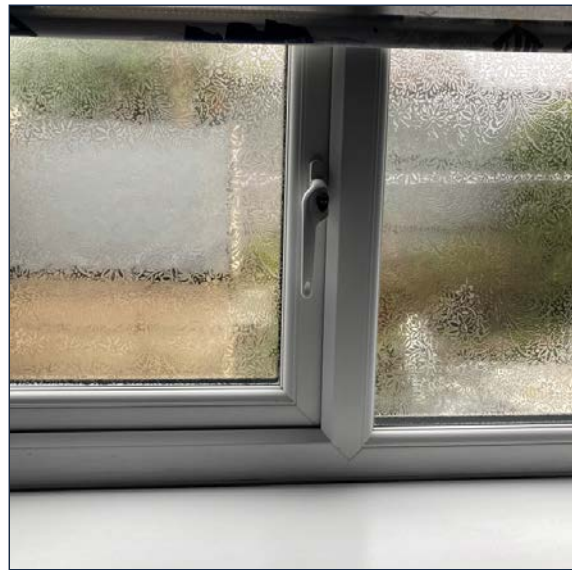
Defect Photography 1

Hot tap when used is loose and turns when tightening. Right window handle loose. Left window unable to test lock function due to no keys. door is catching when returning to close. Skirting board next to door damaged.

Home generally finished to a high level. Some issues to tidy up where there are areas of heavy usage. For example the tap in the bathroom , to turn on and off should be switched to be more intuitive. If left, the tap will always be turned the wrong way and be loosened and at risk of damage or leaking.

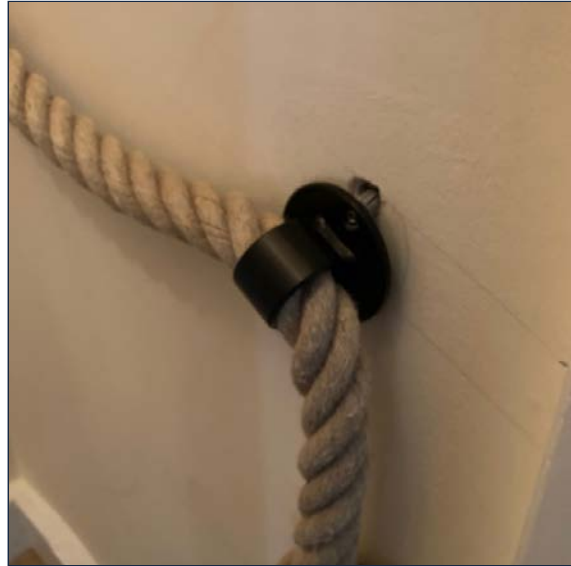
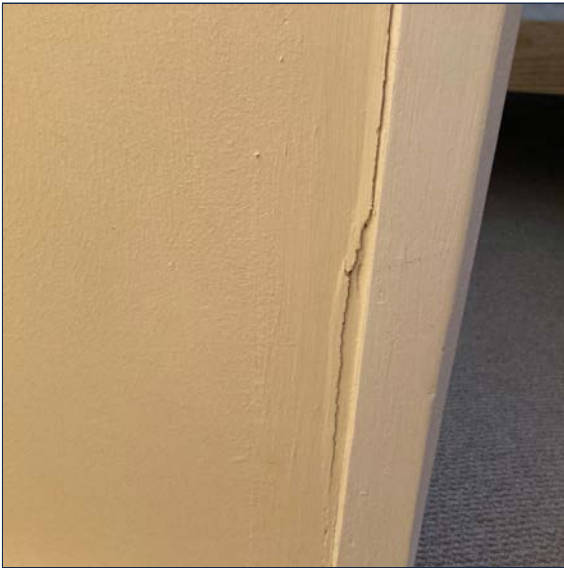
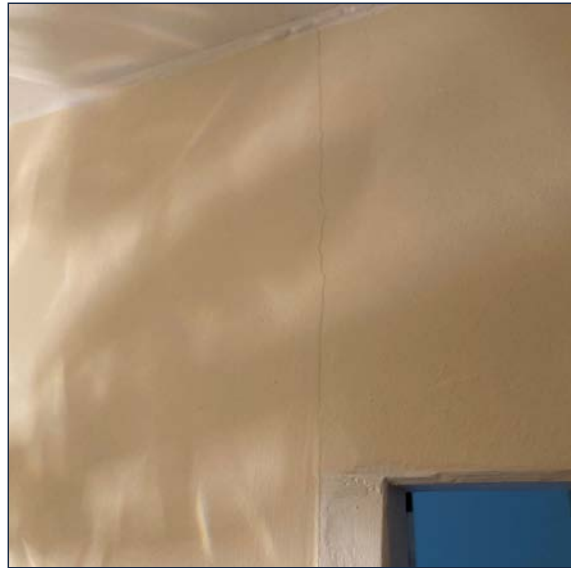
Defect Photography 1

Hairline crack in plaster moving down to the floor next to door trim. Handrail rawl plug coming out of the wall, could present health and safety risk.

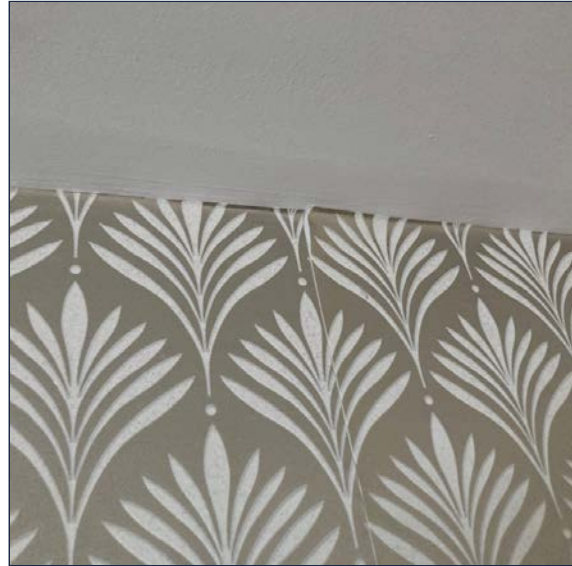
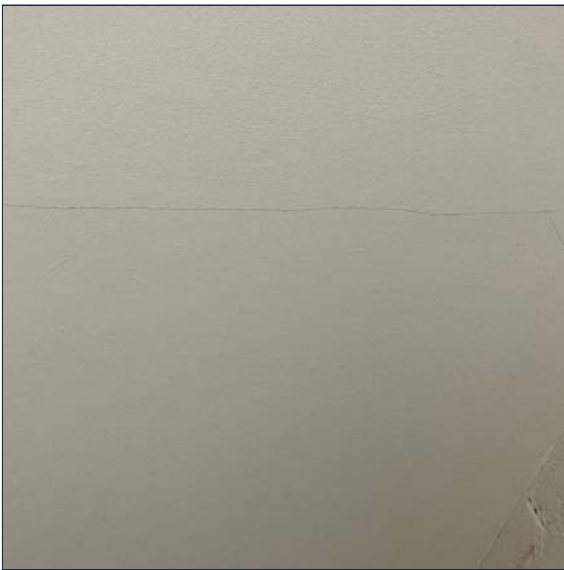
Defect Photography 1

Corner of wallpaper peeling into places. Hairline plaster crack running from chimney column to middle of ceiling near light.

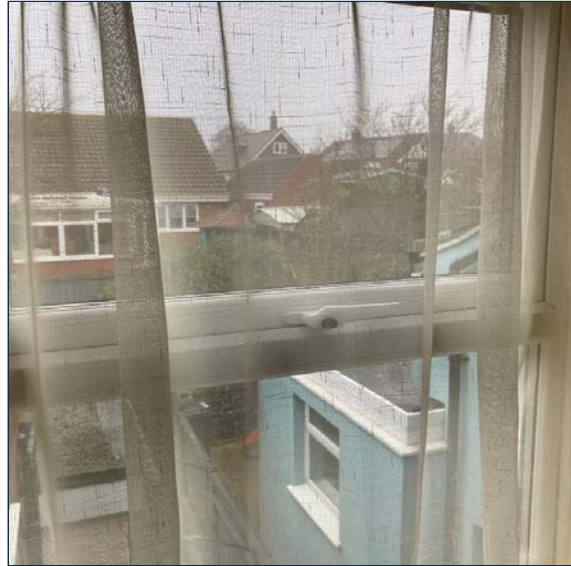
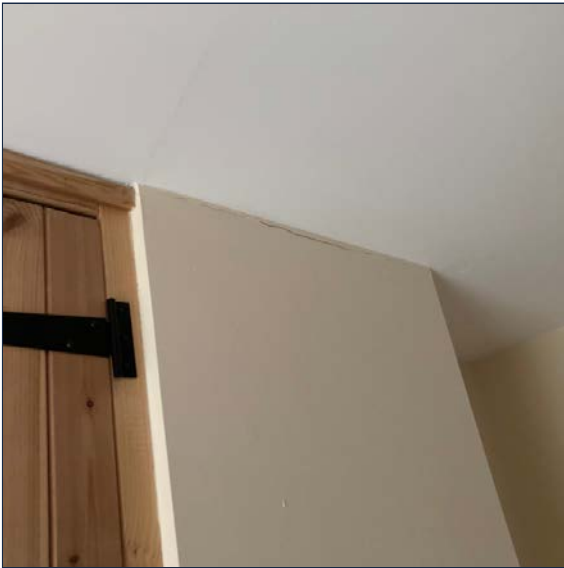
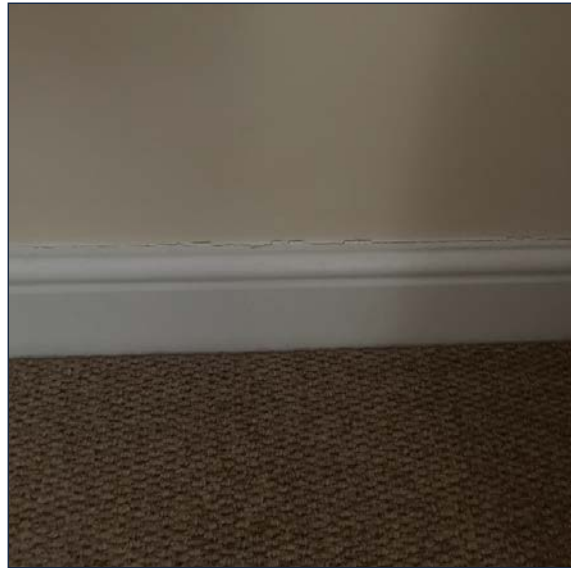
Defect Photography 1

Loft hatch handles loose. Window keys unable to test function due to key is not being present. Crack on the wall to the right of the room from the entrance door. Left-hand skirting board minor crack running along the top.

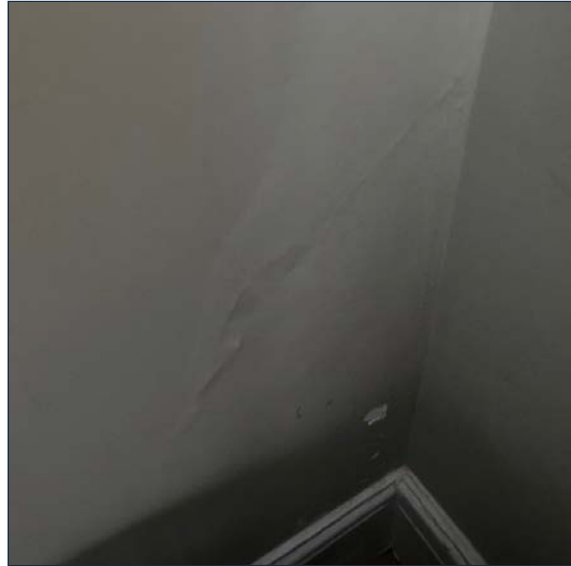
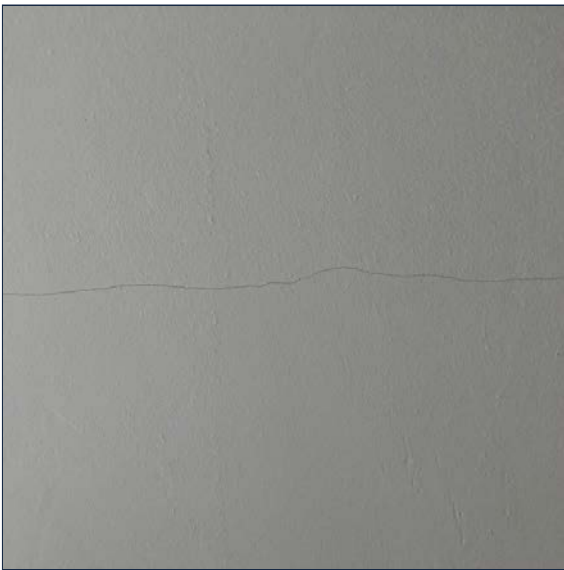
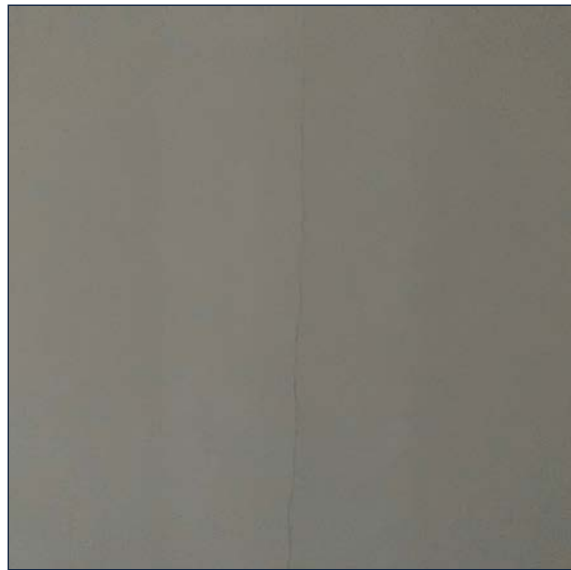
Defect Photography 1

Light cracking to wooden cupboard on right-hand side the lounge as you enter through the main entrance door. In corner near the floor underneath cupboard paint work peeling away and potentially lifting. Surface plaster crack on left-hand wall and on ceiling running from partition wall to window.

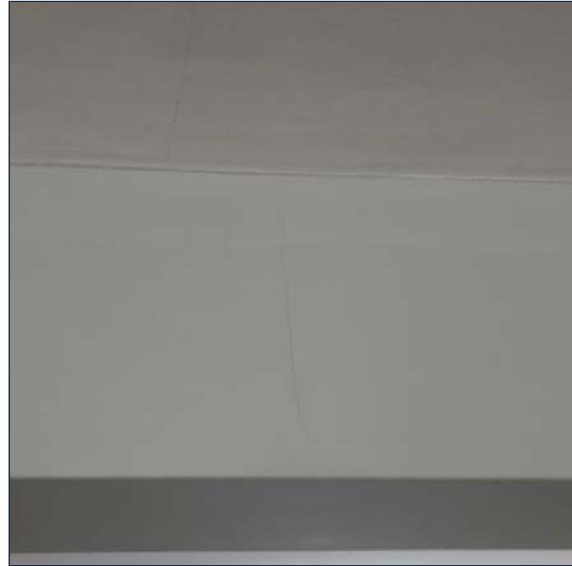
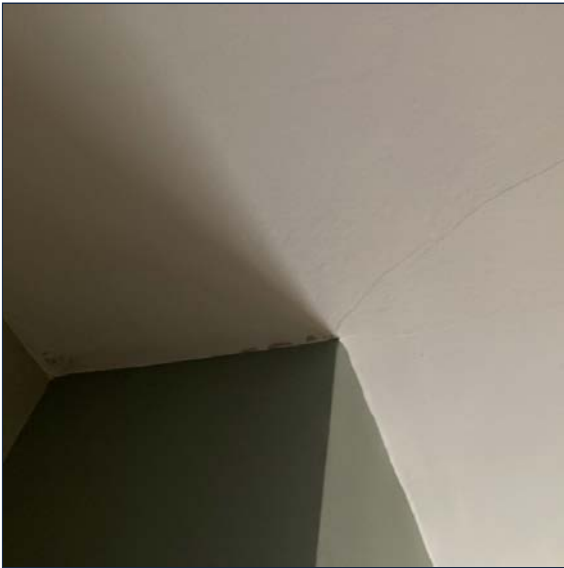
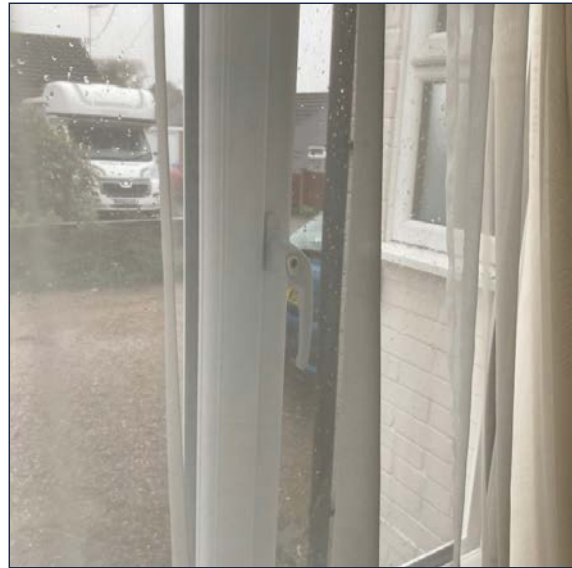
Defect Photography 2

Underneath partition wall there was a slight lift in the ground and gap in flooring could pose a potential trip hazard. In corner above TV paintwork lifting on ceiling and small diagonal plaster crack. Unable to test window for locking function as no key.

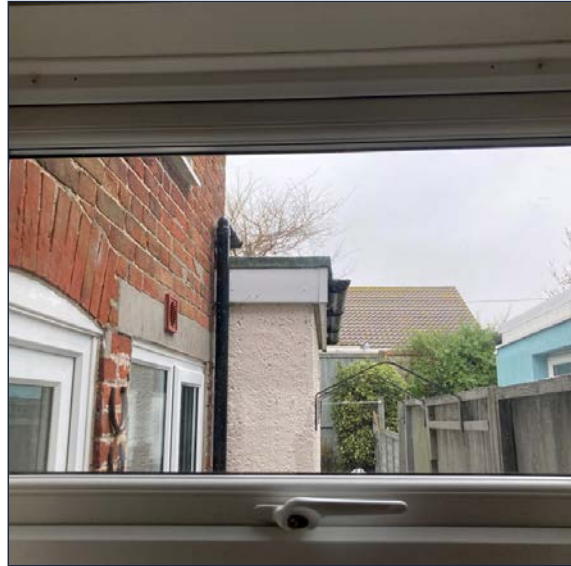
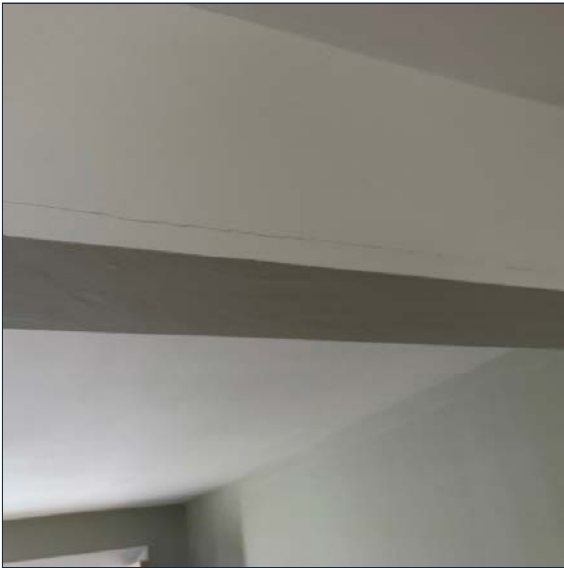
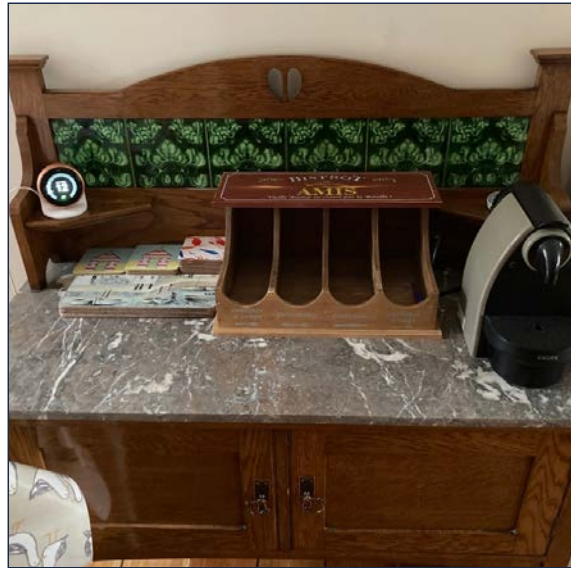
Defect Photography 1

On the floor on the right hand side of the dining room some discolouration. Window has some screw holes and screws poking out of the UPVC. Unable to test locking function due to no keys. behind vintage dresser with coffee machine on unable to get to socket to test.

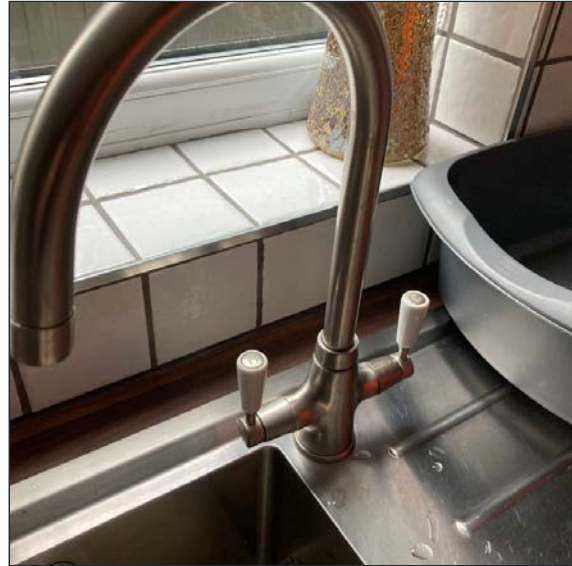
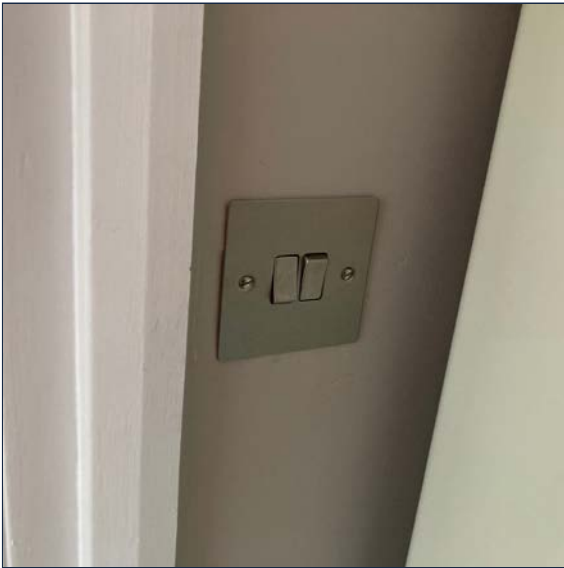
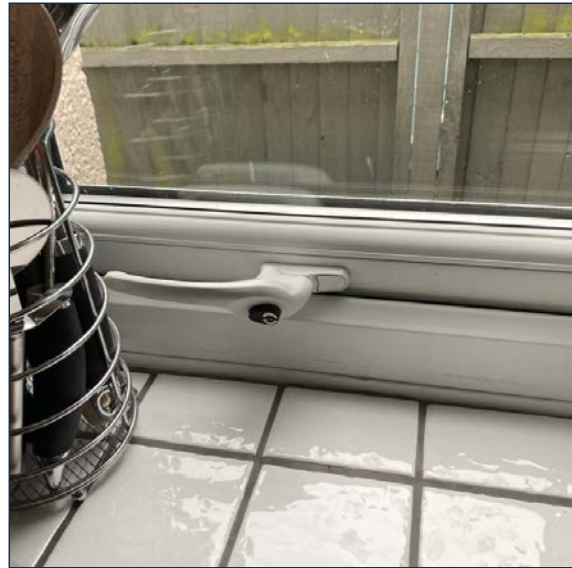
Defect Photography 1

Under the sink the electrical socket is quite close to the surface of the cupboard. Might be worthwhile installing a smart contact water leak detector. Right light switch on light socket does external light but might need labelling. Window handle slightly loose but no keys to test function and currently locked. Tap slightly loose on use.

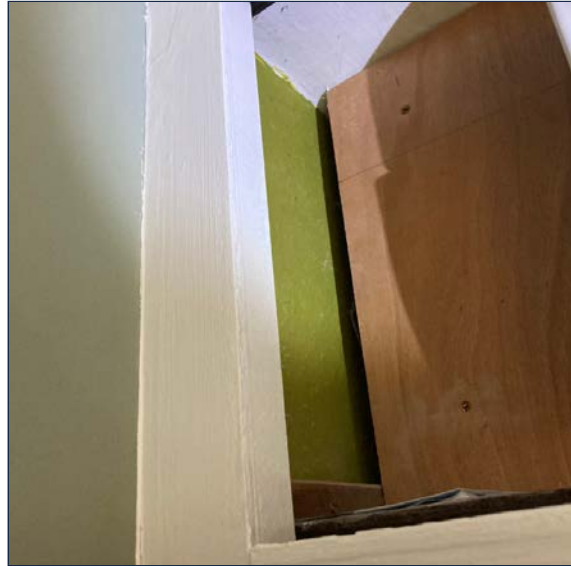
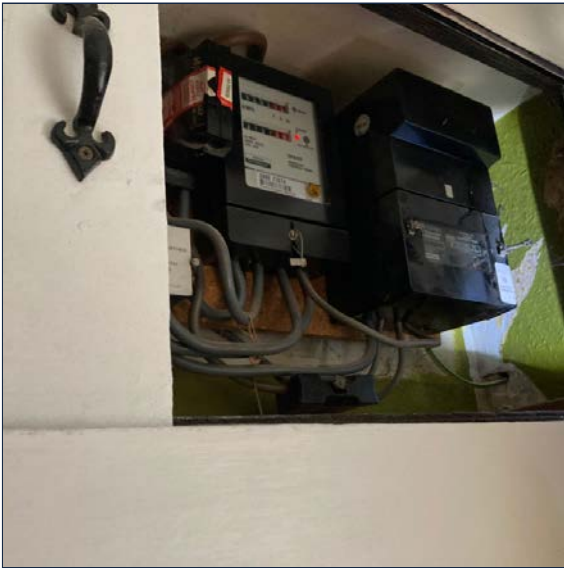
General Condition Photography

Consumer unit is not easily accessible as the housing catches on the sliding cupboard door. Some damage to ceiling. Walls are decorated differently.

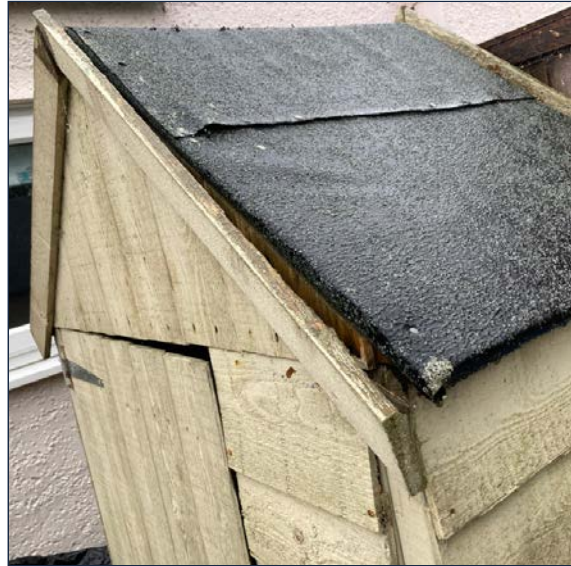
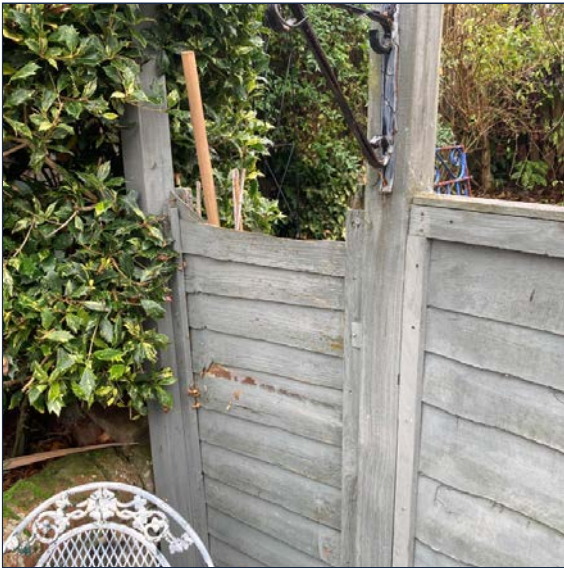
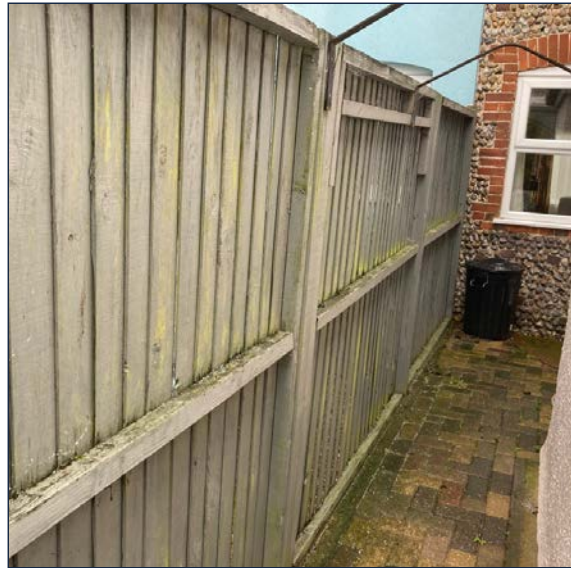
Defect Photography 1

External sockets do not turn off. Trim on shed is coming away needs re-sticking. Far right hand corner of garden fence panel is broken. All of the fence could use some TLC due to green discoloration.

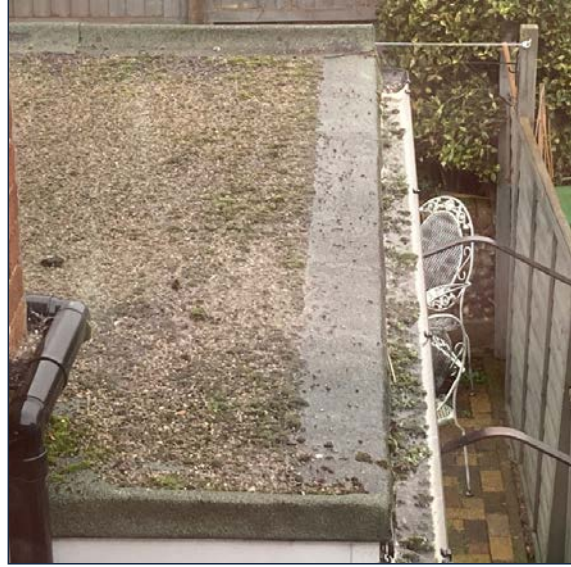
Defect Photography 2

External tap is not over the drain. Tray needs clearing as full of debris. Flat roof and guttering could use clearing as preventative maintenance.

Externally, need general preventative planned maintenance to be done to the flat roof and rainwater goods. The roof could be cleared of moss as a part of this maintenance. The guttering was not able to be viewed from above but based on the flat roof guttering that needs clearing it is possible the main guttering also needs clearing.

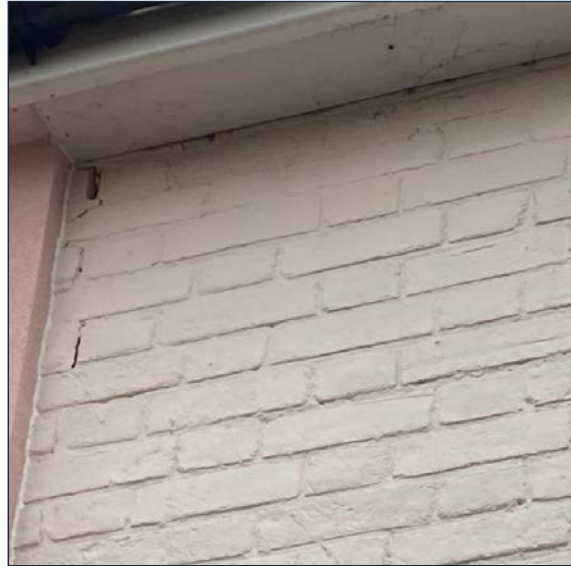
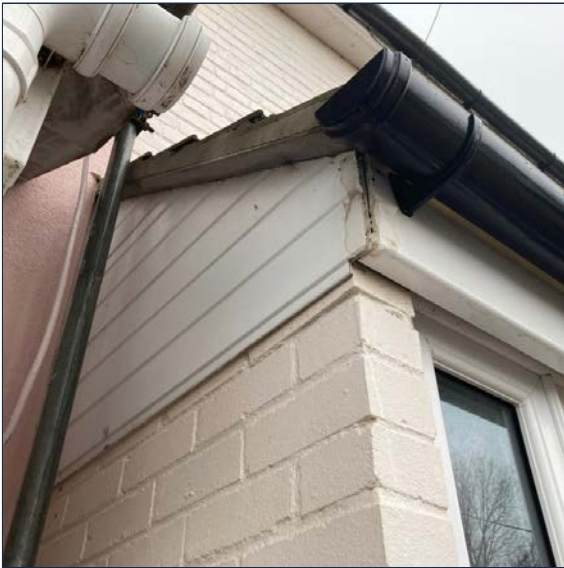
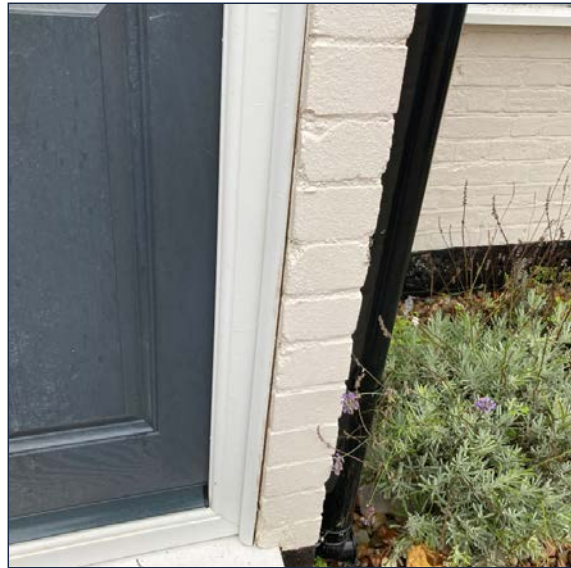
Defect Photography 1

Trim on right-hand side of door is loose. Archway to porch likely to need some source sealant around the edges. Repointing required on top left-hand corner brickwork.

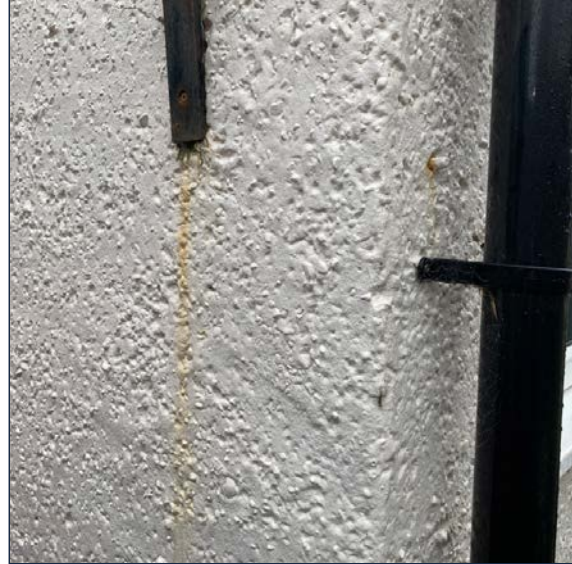
Defect Photography 1

Metal archway causing paint discolouration.
