Property Report Interior Visual and Practical Plus Exterior

19 April 2021

COCKLESHELL
COTTAGE

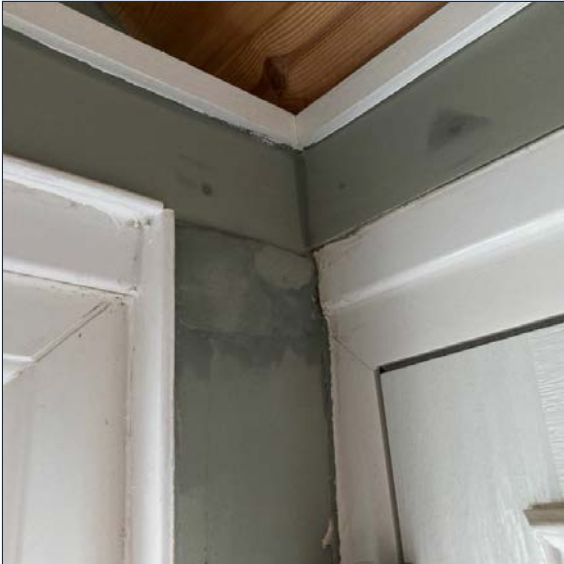
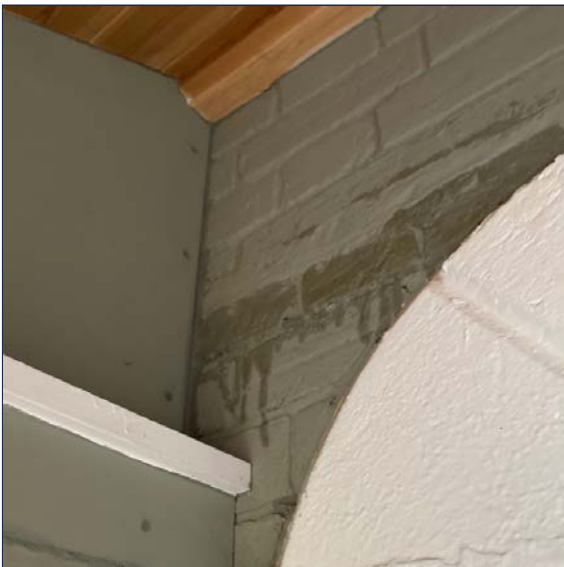
Defect Photography 1

There are signs of water ingress and the UPVC trim above the door is loose and coming away.

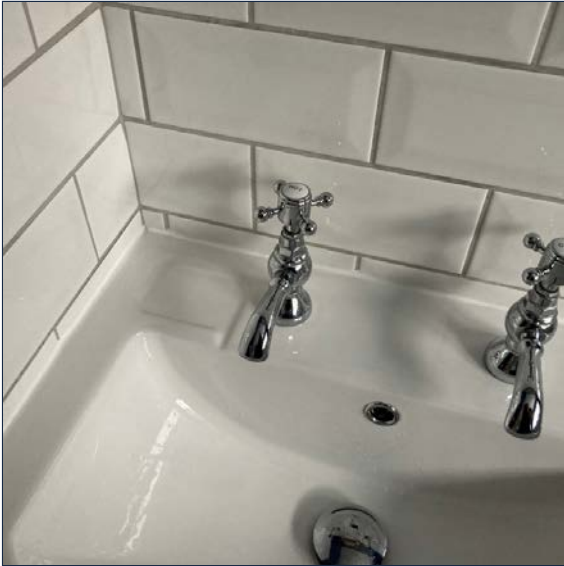
Defect Photography 1

Hot tap when used is loose and turns when tightening. Right window handle loose. Left window unable to test lock function due to no keys. door is catching when returning to close. Skirting board next to door damaged.

Home generally finished to a high level. Some issues to tidy up where there are areas of heavy usage. For example the tap in the bathroom , to turn on and off should be switched to be more intuitive. If left, the tap will always be turned the wrong way and be loosened and at risk of damage or leaking.

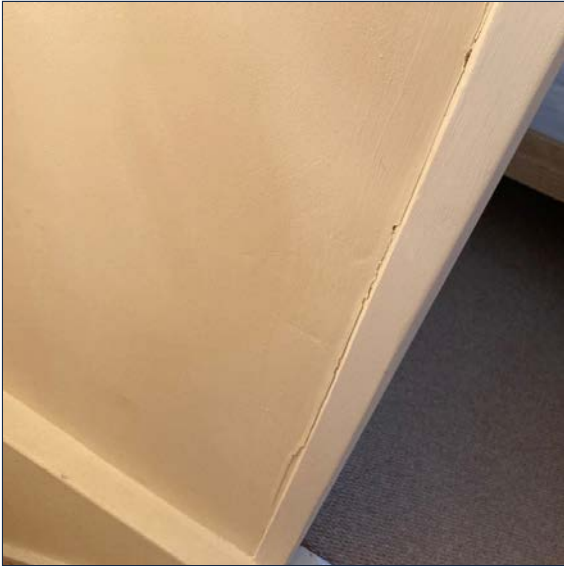
Defect Photography 1

Hairline crack in plaster moving down to the floor next to door trim. Handrail rawl plug coming out of the wall, could present health and safety risk.

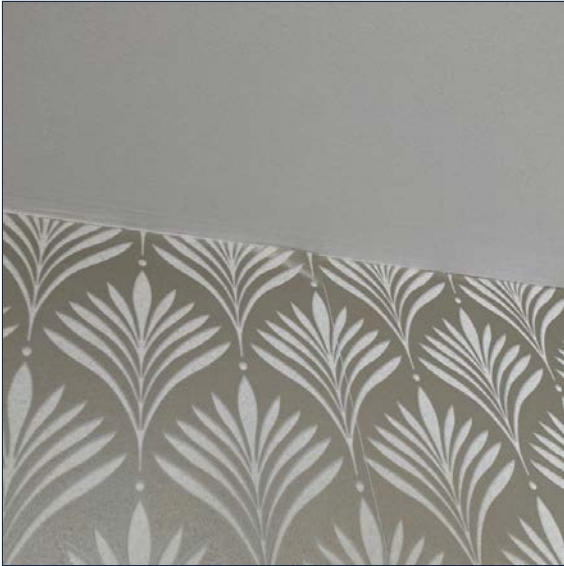
Defect Photography 1

Corner of wallpaper peeling into places. Hairline plaster crack running from chimney column to middle of ceiling near light.

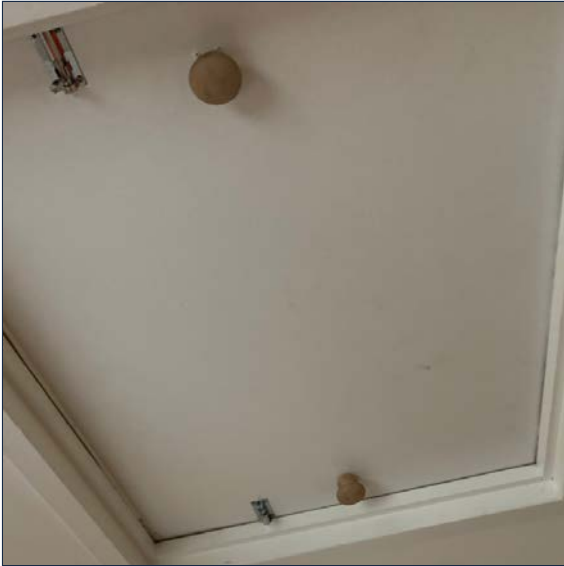
Defect Photography 1

Loft hatch handles loose. Window keys unable to test function due to key is not being present. Crack on the wall to the right of the room from the entrance door. Left-hand skirting board minor crack running along the top.

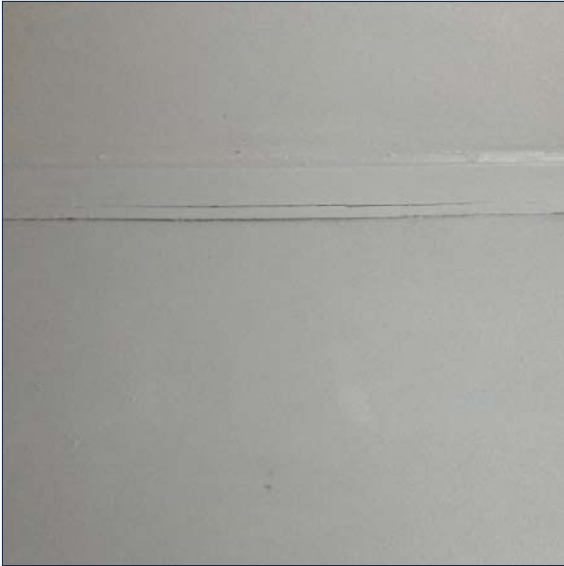
Defect Photography 1

Light cracking to wooden cupboard on right-hand side the lounge as you enter through the main entrance door. In corner near the floor underneath cupboard paint work peeling away and potentially lifting. Surface plaster crack on left-hand wall and on ceiling running from partition wall to window.

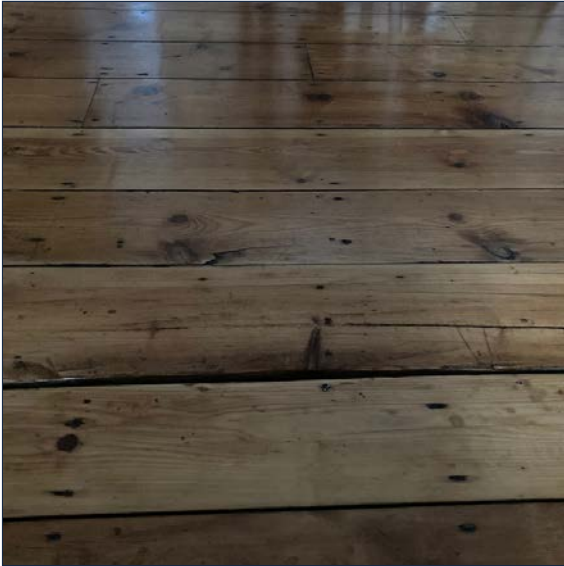
Defect Photography 2

Underneath partition wall there was a slight lift in the ground and gap in flooring could pose a potential trip hazard. In corner above TV paintwork lifting on ceiling and small diagonal plaster crack. Unable to test window for locking function as no key.

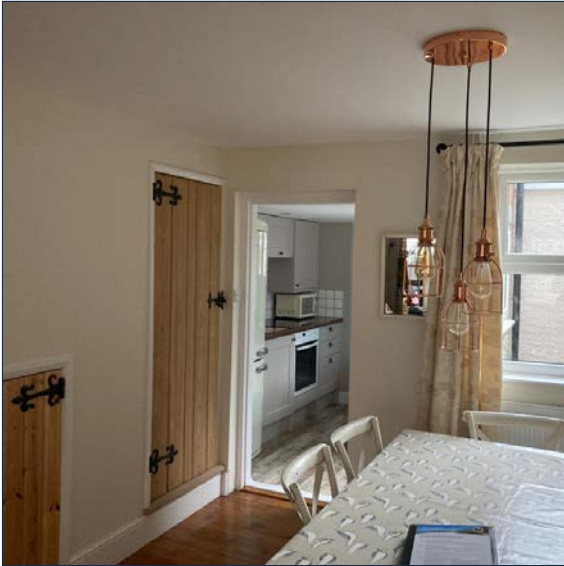
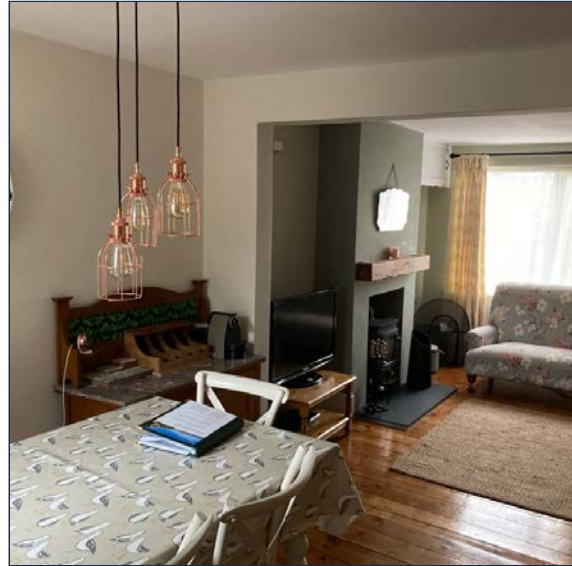
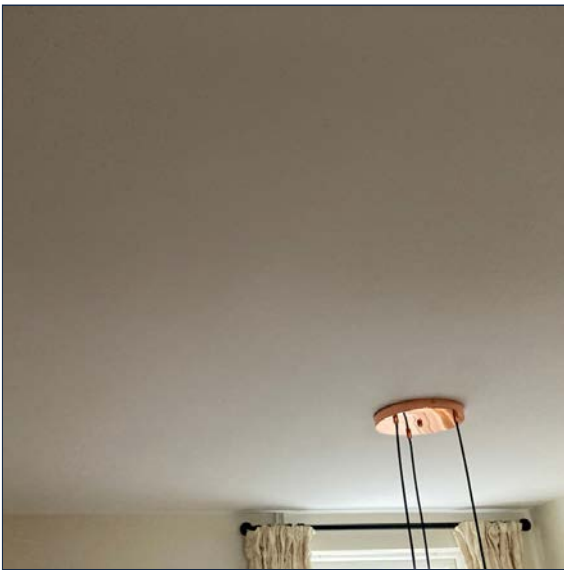
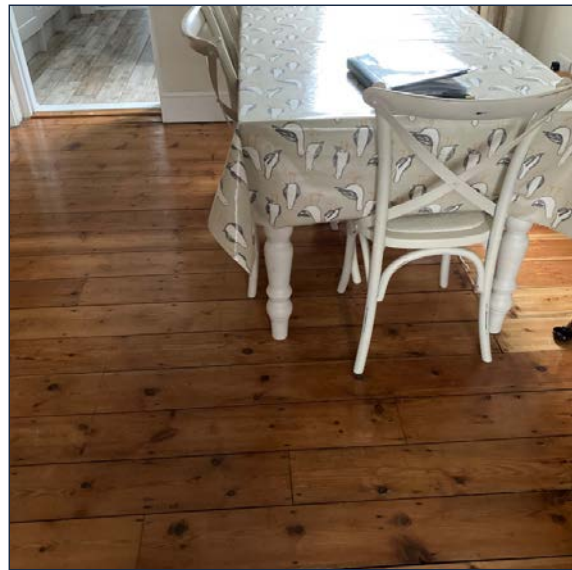
Internal: Dining Room

There is a defect which has been recorded in the defect section. The walls are a painted finish. The ceiling is a painted finish. The floor is a wood or laminate finish.

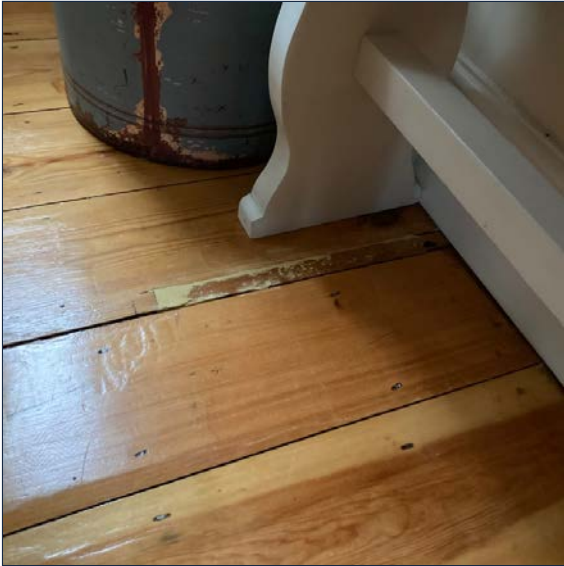
Defect Photography 1

On the floor on the right hand side of the dining room some discolouration. Window has some screw holes and screws poking out of the UPVC. Unable to test locking function due to no keys. behind vintage dresser with coffee machine on unable to get to socket to test.

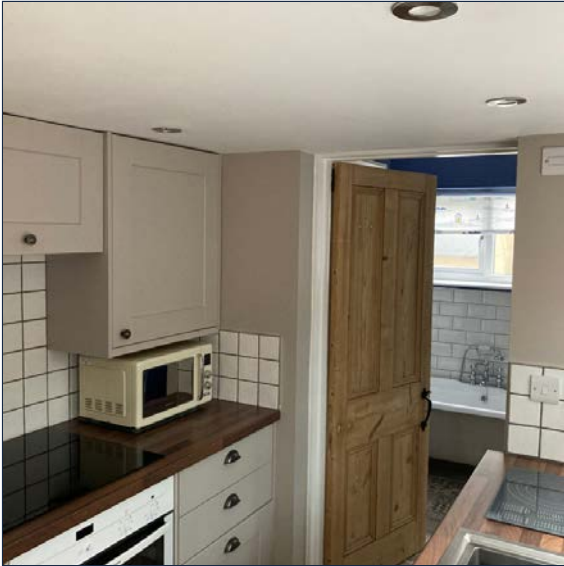
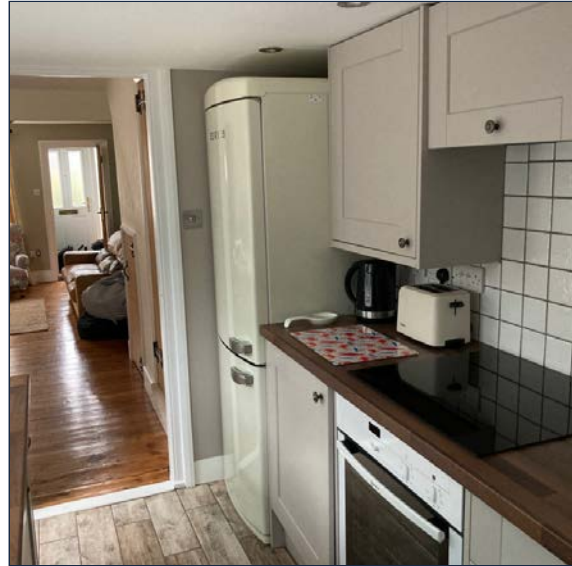
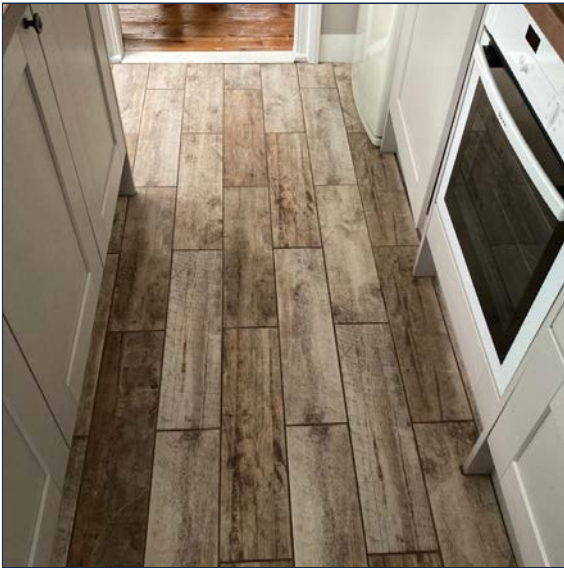
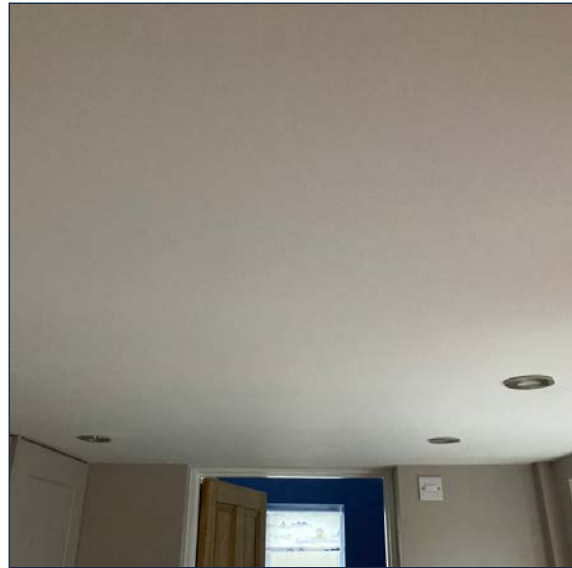
Internal: Kitchen

There is a defect which has been recorded in the defect section. The walls are a painted finish. The ceiling is a painted finish. The floor is a tiled wood effect finish.

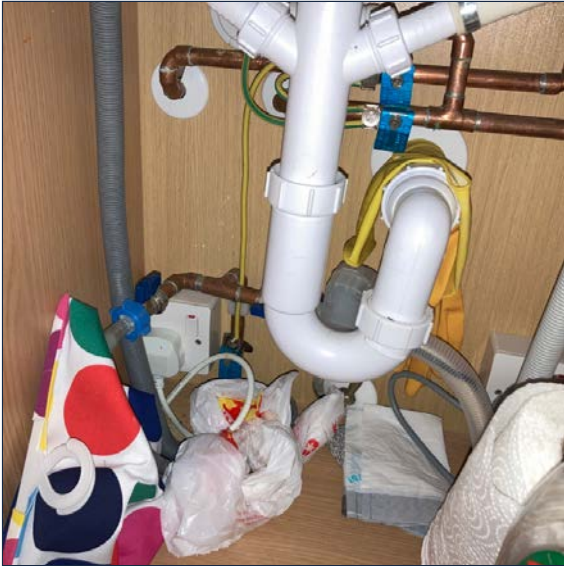
Defect Photography 1

Under the sink the electrical socket is quite close to the surface of the cupboard. Might be worthwhile installing a smart contact water leak detector. Right light switch on light socket does external light but might need labelling. Window handle slightly loose but no keys to test function and currently locked. Tap slightly loose on use.

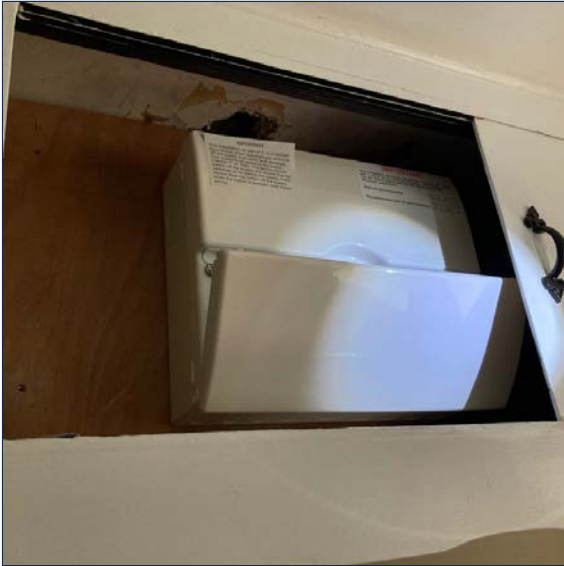
Internal: Consumer Unit

Consumer unit is not easily accessible as the housing catches on the sliding cupboard door. Some damage to ceiling. Walls are decorated differently.

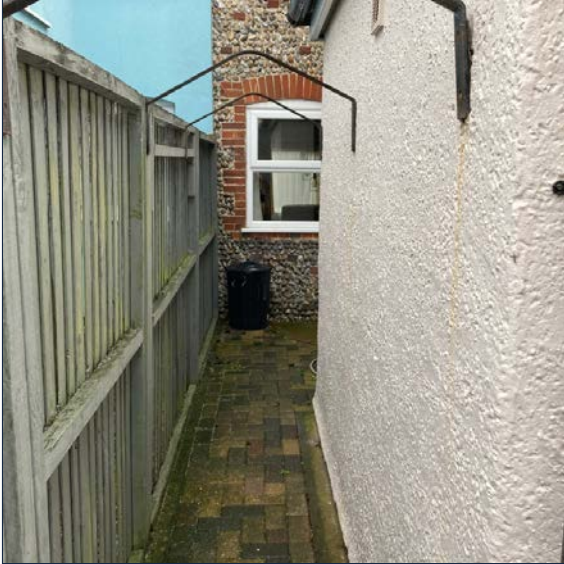
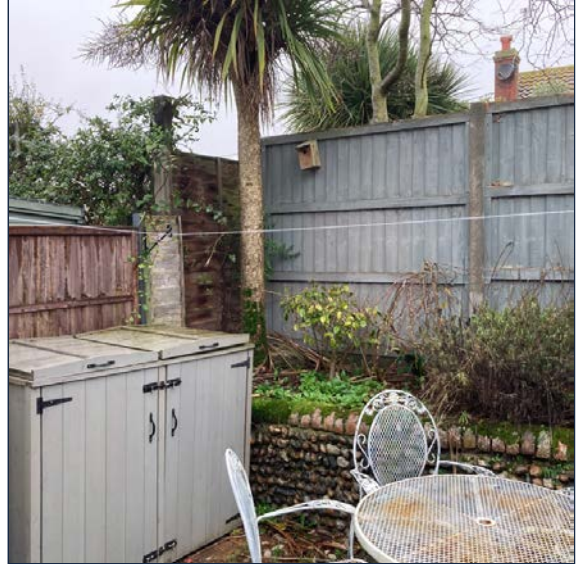
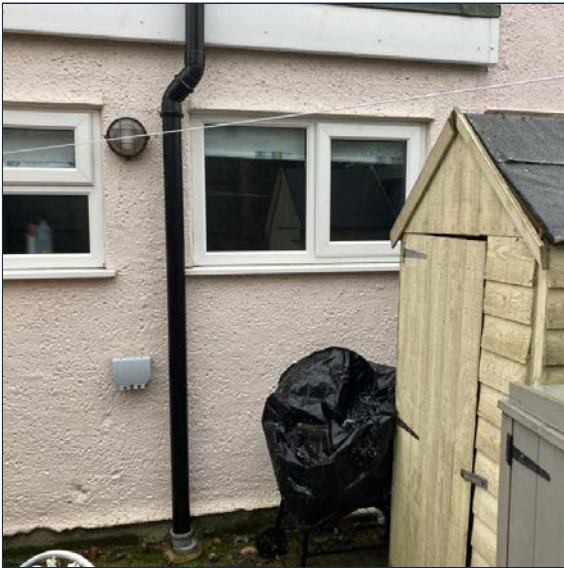
External: Back Garden

There is a defect which has been recorded in the defect section.

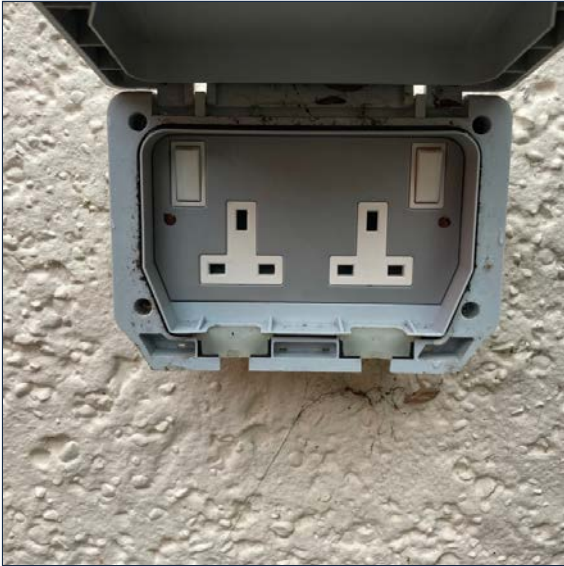
Defect Photography 1

External sockets do not turn off. Trim on shed is coming away needs re-sticking. Far right hand corner of garden fence panel is broken. All of the fence could use some TLC due to green discoloration.

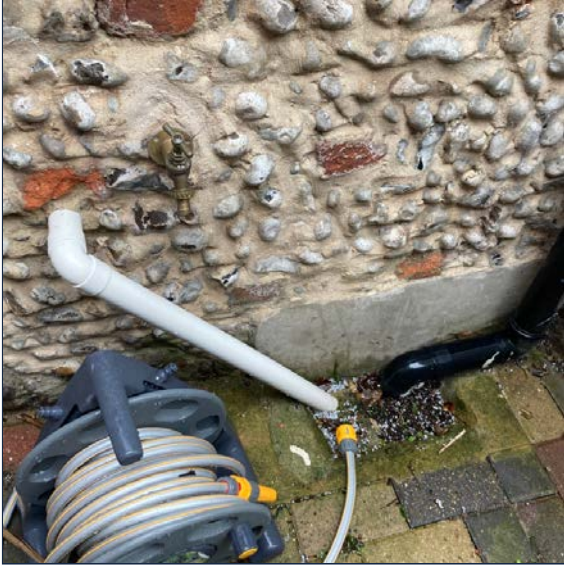
Defect Photography 2

External tap is not over the drain. Tray needs clearing as full of debris. Flat roof and guttering could use clearing as preventative maintenance.

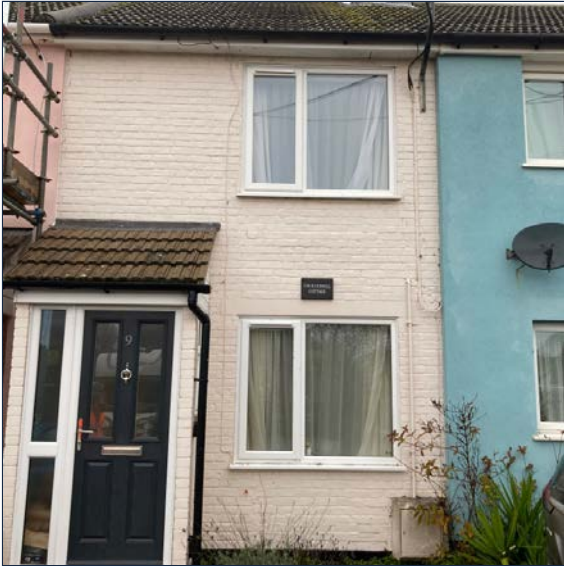
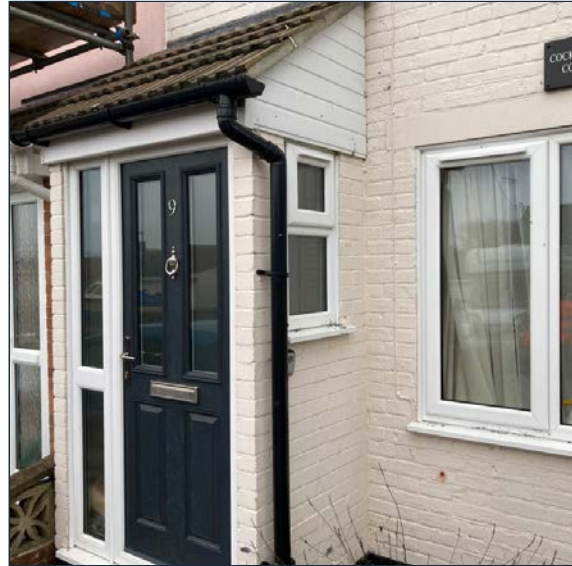
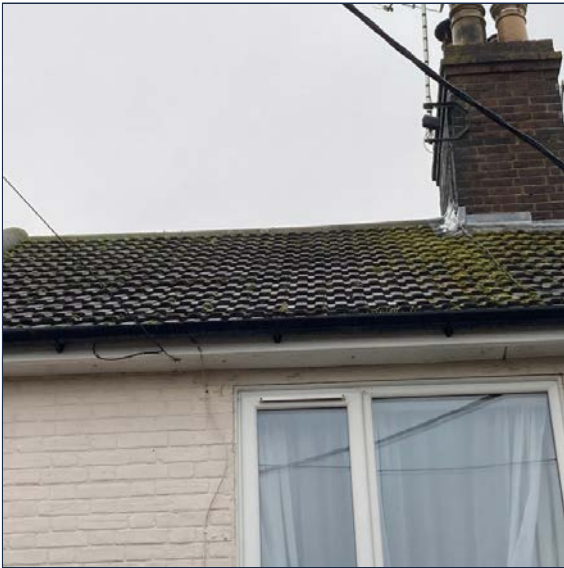
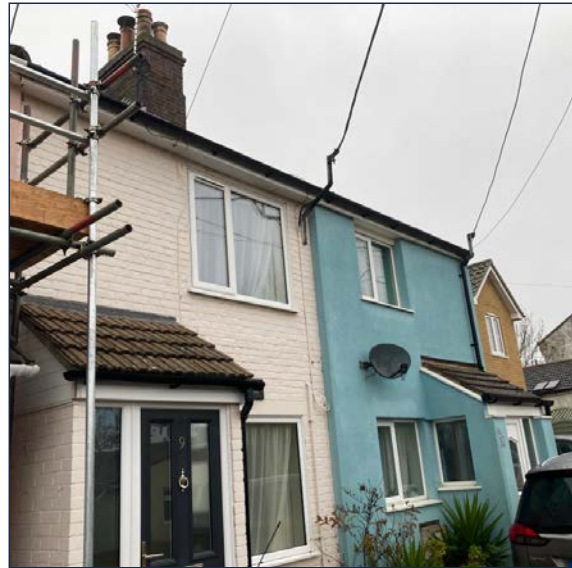
External: Front Elevation

There is a defect which has been recorded in the defect section.

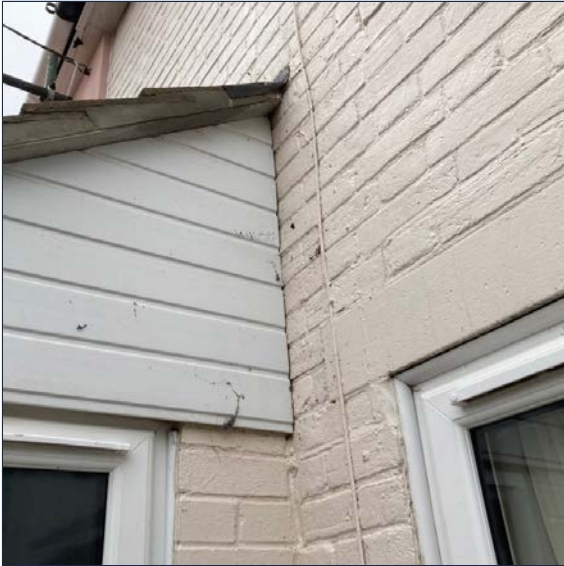
Defect Photography 1

Trim on right-hand side of door is loose. Archway to porch likely to need some source sealant around the edges. Repointing required on top left-hand corner brickwork.

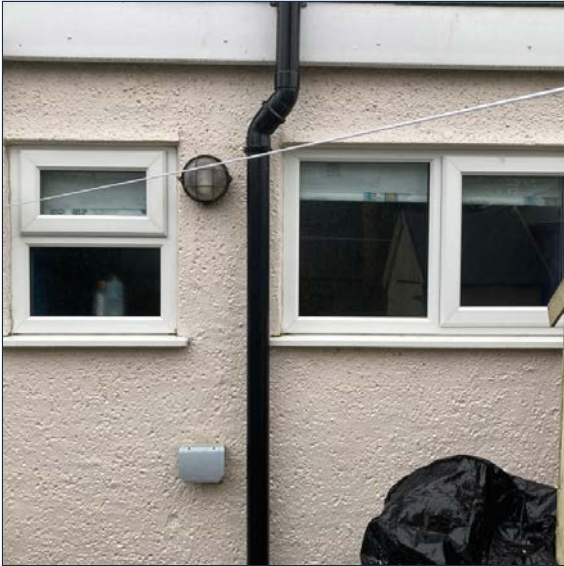
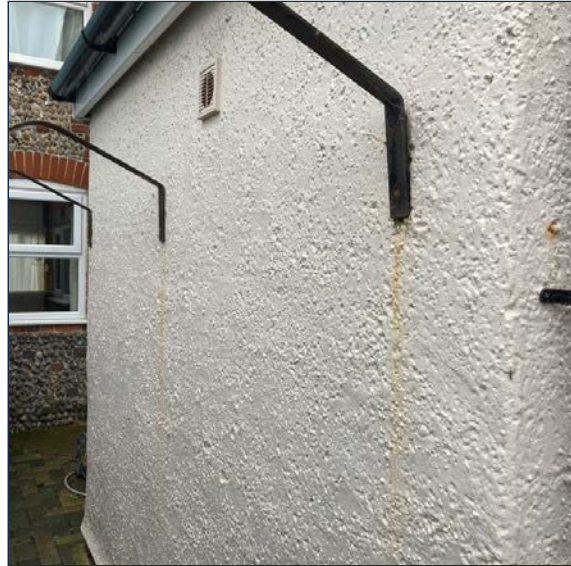
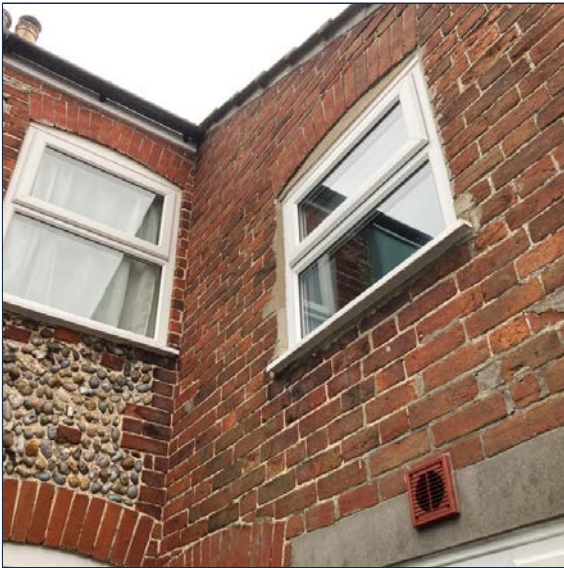
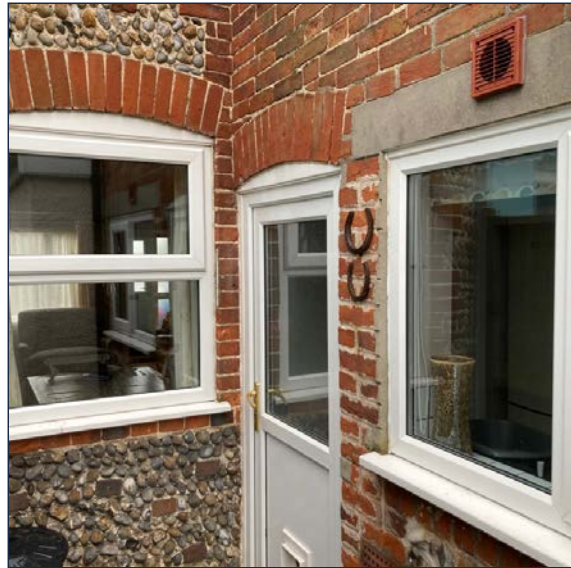
External: Back Elevation

There is a defect which has been recorded in the defect section.

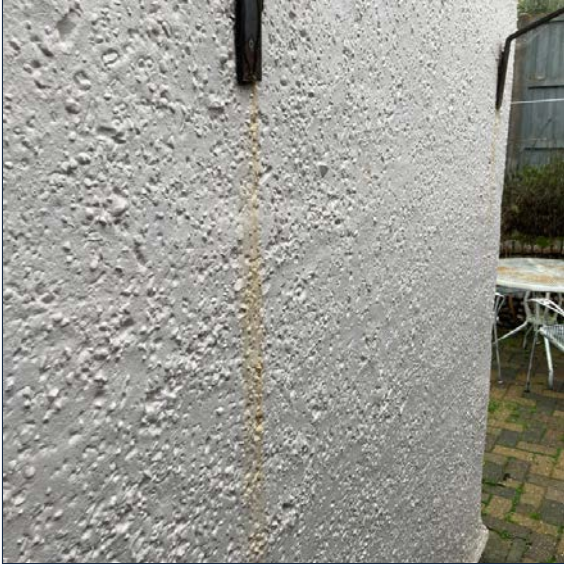
Defect Photography 1

Metal archway causing paint discolouration.
